BUILDING
MATERIALS
AND
STRUCTURES

REPORT BMS253

Structural Properties of
Conventional Wood-Frame
Constructions for Walls
Partitions, Floors, and Roofs

GEORGE E. HECK

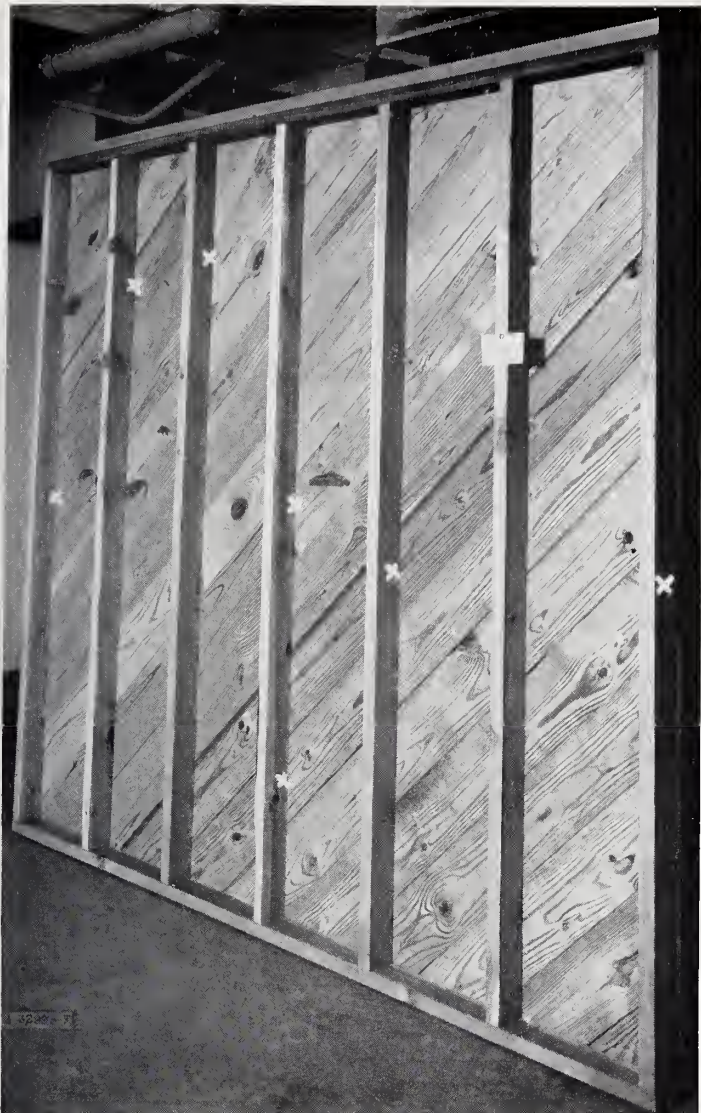
FIGURE 5.—Wall specimen QA before application of laths, plaster, or siding, showing construction of 8- by 8- ft. specimens and position of joints in sheathing (indicated by x's).

In racking tests the horizontal forces were applied in the direction to cause tension in the sheathing, i. e., pushing toward the right at the top of the specimen and toward the left at the bottom.

The walls were tested with the diagonal sheathing stressed in tension (fig. 5), which previous tests have indicated is the weaker direction.

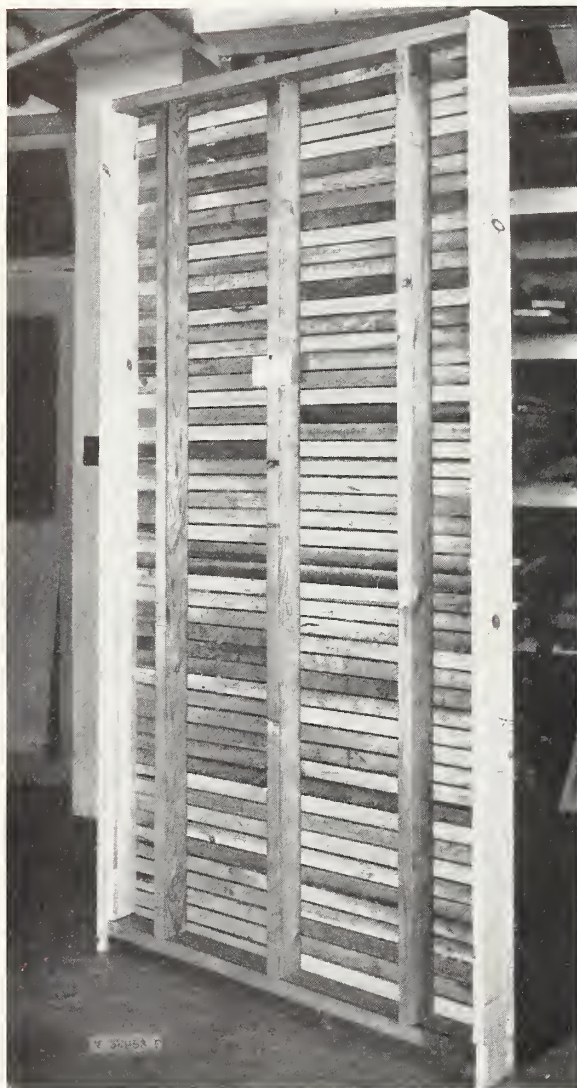
FIGURE 6.—Partition specimen QD-T1 with laths on one face only.

The pieces shown at vertical edges formed supports for lath ends and grounds for plastering and were removed before the specimen was tested.

blued lath nail at each stud crossing. The laths were applied in courses of eight laths each, the joints being broken in a uniform manner for each size of specimen, 51 widths of lath being required in each instance. Support for the 8-in. overhang of the lath at each edge of the 4-ft specimens was provided in conjunction with the plastering grounds, the supporting pieces being removed before test (fig. 6).
